# Manhole Inspection Summary

Manhole # S33E\_\_034MH

Insp Date: **8/1/08 10:35 AM**

**Location** Address: **222 liberty st**

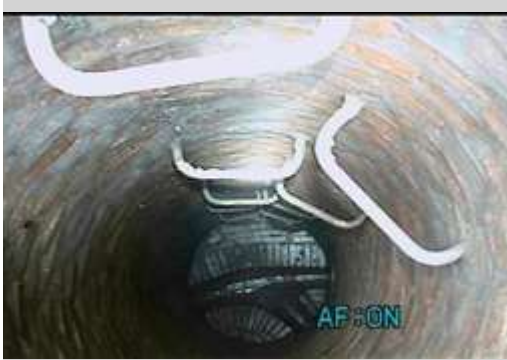
Defect 2

Count: **12** Missing: **0** ☒ **Corroded**

steps

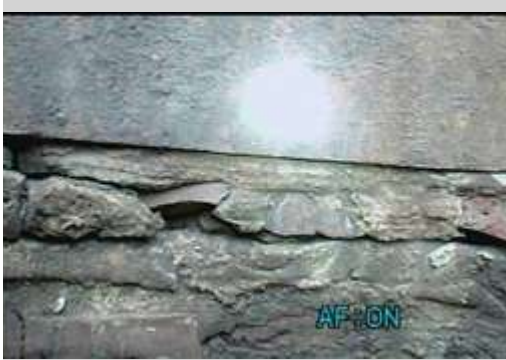
Defect 1

Condition: ☐ Sound ☒ **Cracked** ☐ Root Intrusion ☒ **Loose Brick** ☐ Deteriorated

chimney cracked and loose bricks, frame adj

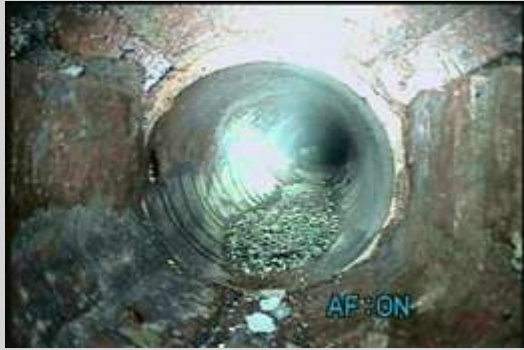
8 O'Clock Inflow

Deposits: ☐ None ☐ Mud ☐ Sludge ☒ **Debris** ☐ Grease

Silt Depth: 2 (in.) Deposits Extent: **Light**
